# MERIAM HOUSE

Minute Man National Historical Park  
Concord, Massachusetts

## Historic Structure Report

Barbara A. Yocum, Architectural Conservator  
Historic Architecture Program, Northeast Region  
National Park Service  
Lowell, Massachusetts

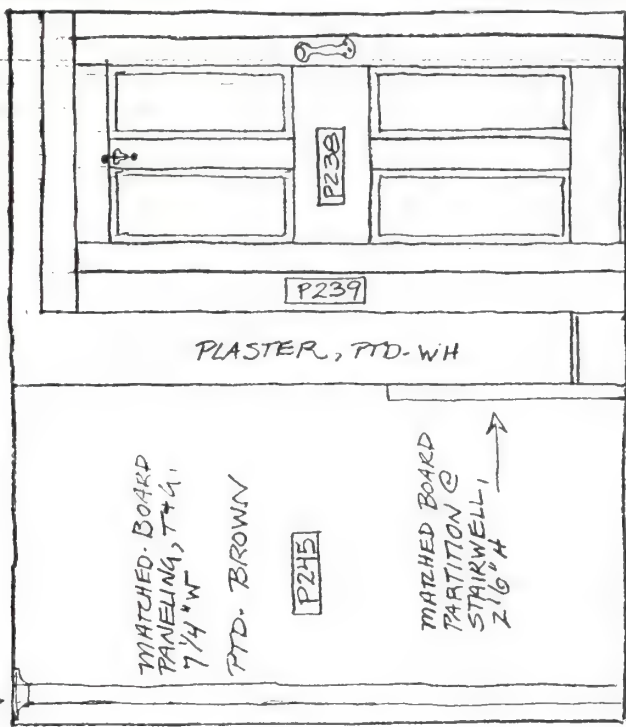
SOUTH WALL

DOORWAY: TO RM 205; UNMORTISED;  
METAL DOORKNOB; X2 2-KNUCKLE  
FINISHES; LARGE ATTACHED  
MIRROR; SEE RM 205 FOR  
DOOR DIMENSIONS; PLAIN BOARD  
ARCHITRAVE

FINISHES: WOODWORK PAINTED BROWN  
(OVER RED); PLASTER WALL PTD.  
WHITE.

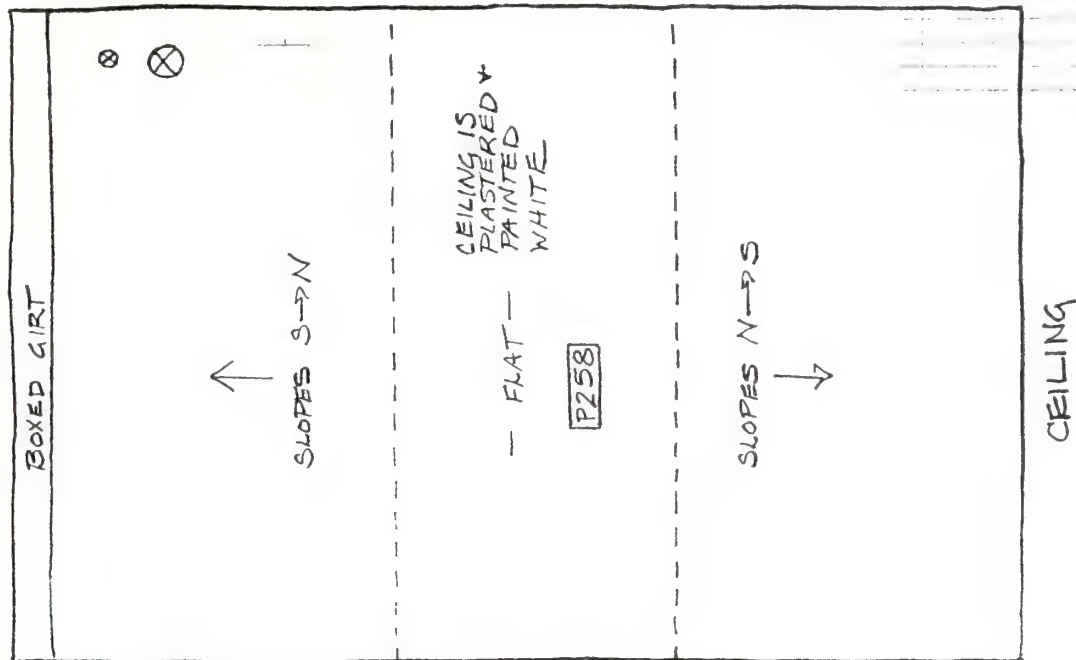
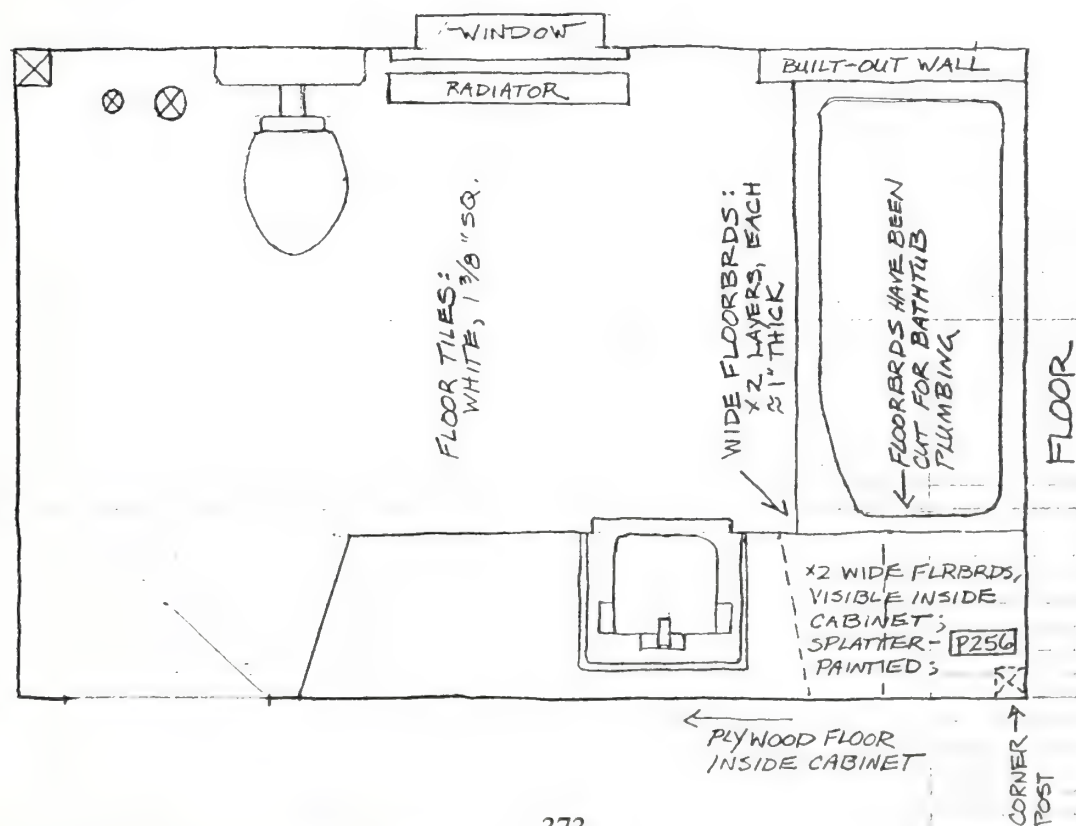
MIMA: MERIAM HS.  
 RM 208, FLOOR & CEILING  
 SEPT. 28, 1993; B. Yocum  
 SCALE: 1/2" = 1'0"

FINISHES: PLASTER & BOXED  
GIRT/POST PAINTED WHITE;  
BASEBOARD PTD. BLACK.

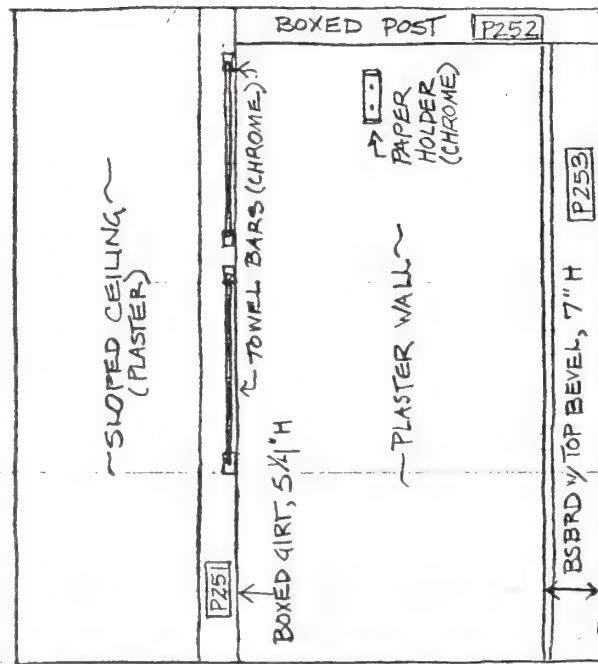
NORTH WALL

MIMA: MERIAM HS  
RM 208, NORTH & SOUTH WALLS  
SEPT. 28, 1993; B. YOCUM

FINISHES: SIDE WALL HAS  
BLACK TILES, 4 1/8" SQ.;  
CEILING IS PLASTERED &  
PAINTED WHITE.

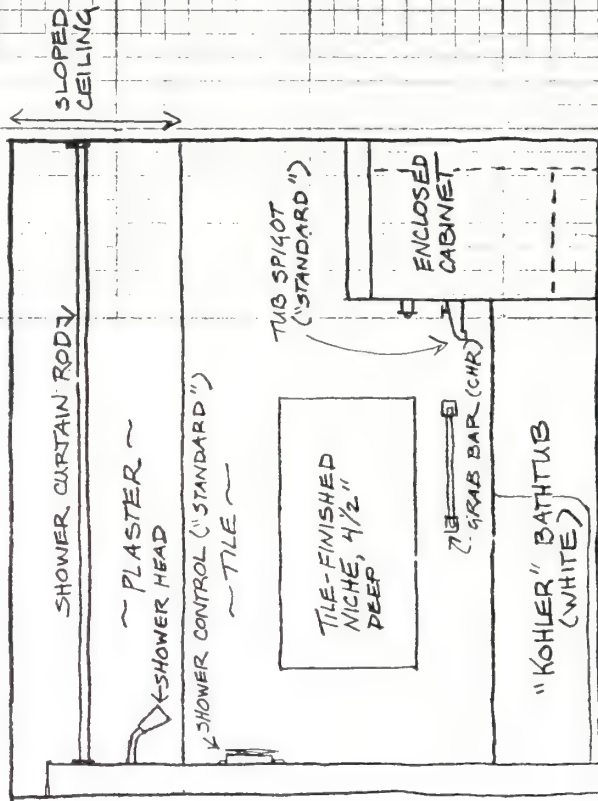
SOUTH WALL

INSIDE CABINET:  
BOXED POST,  
PLAIN BSBRD &  
PLASTER WALL  
VISIBLE.

FINISHES:  
BLACK PAINT - DOOR + CABINET BASE  
WHITE PAINT - PLASTER WALL + DOORWAY ARCHITRAVE

CABINET INTERIOR:  
- PLASTER WALL PTD. GRAY;  
- BSBRD, 7 1/2" H, W/ BEVEL, PTD. DARKER GRAY  
- SW CORNER POST, PTD. SAME AS BSBRD  
- WIDE E-W FLOORBOARDS, PTD. RED-BROWN, W/ SPATTERED DECORATION (YELLOW, BLACK, GREEN, RED + GRAY)

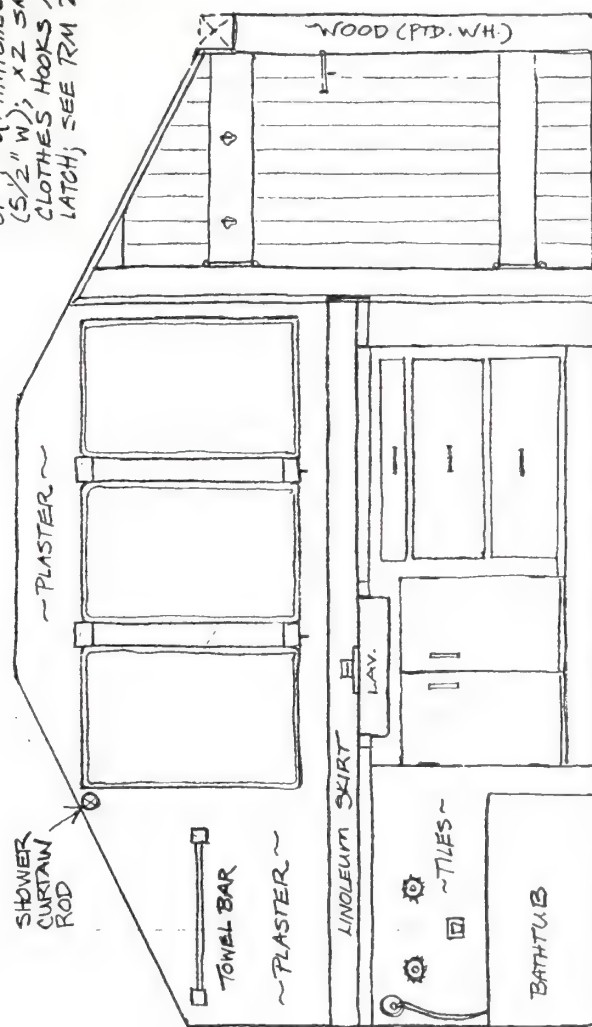
CABINET: SIMILAR STYLE TO BUILT-IN DRAWERS, RM 203; COUNTER TOP + BACK SKIRT IS LINOLEUM (FAUX RED MARBLE); BASE FRAME, DOORS + DRAWERS PTD. BLACK; HANDLES ARE METAL (SILVER METAL)

LAVATORY: WHITE; NO MANUFACTURER; INFO. WRITTEN ON UNDERSIDE: "MADE IN U.S.A."; "376 110 20"; "MLH" + "707"; FAUCET IS "AMERICAN STANDARD"

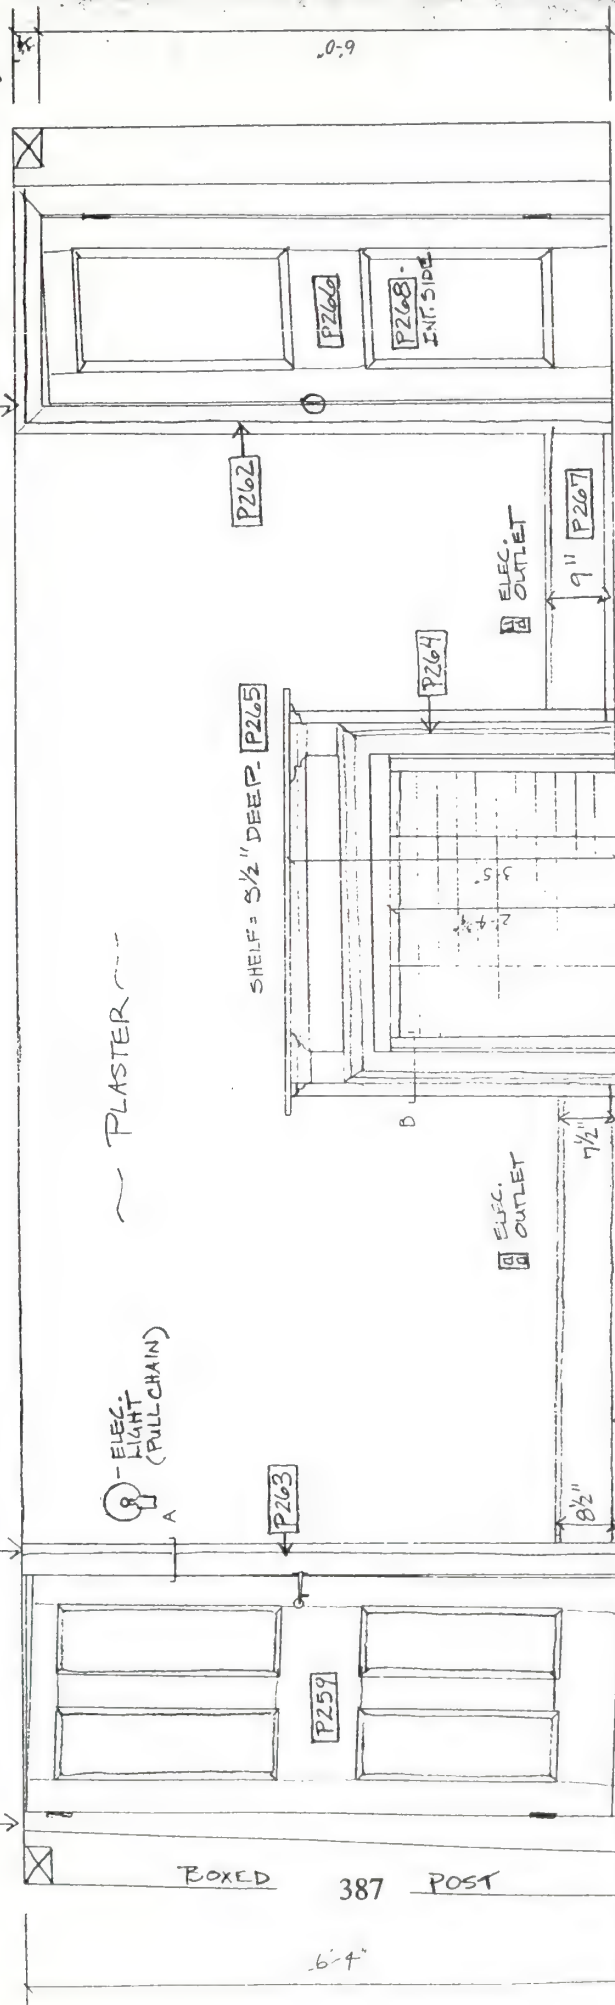
CLOSET DOOR: APPEARS TO BE IN  
ORIG. LOCATION. MORTISED,  
RAISED PANELS RM SIDE, RECESSED  
UNMOLDED PANELS CL SIDE; X 2  
3-KNUCKLE HINGES; 2" DIAM.  
(BRASS?) SWIVEL LATCH RM SIDE;  
DOOR MEASURES:  
1' 11" W X  
5' 10 7/8" H X  
1" THK  
THRESHOLD - 4" WIDE

FIREPLACE:  
MANTEL = RM 202;  
FIREBOX IS ~ 1' 4" DEEP;  
2' 9 1/2" W X 2' 2 1/2" H;  
FACE BRICKS PAINTED  
BLACK (2 2" W)

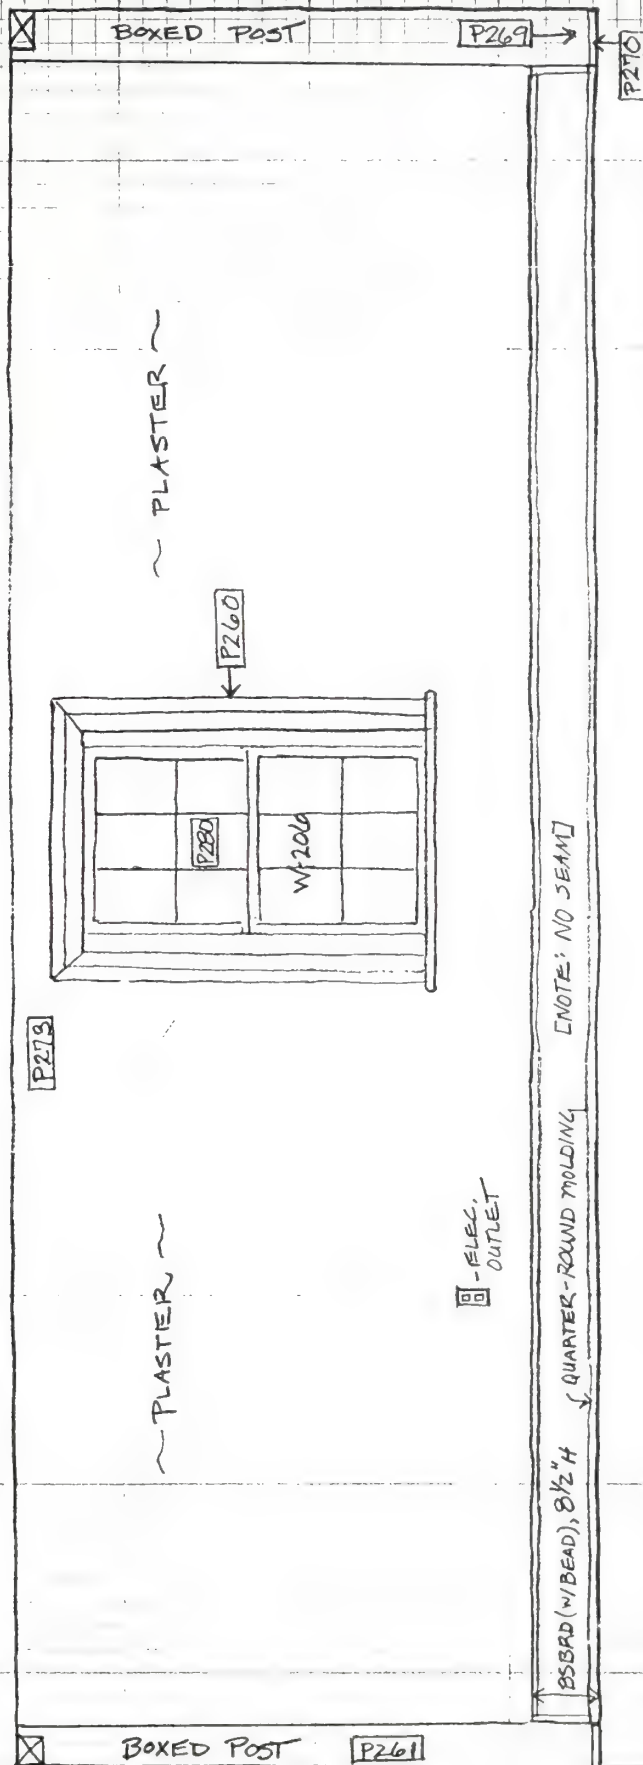
MINIMA: MERIAM HS.  
RM 209, EAST WALL  
SEPT. 10, 1993; B. Yocum  
SCALE: 1/2" = 1'0"

WINDOW: 6/6 SASH, STAYETS  
JAMBS: ARCHITRAVE, MULDING  
SAME AS SOUTH WINDOWS +  
WEST DOORWAYS (ALSO, RMS  
102, 108, 201 WINDOW + 202).

PLASTER: GOOD CONDITION.  
DARK "SHADOWS" INDICATE  
WOOD LATH. APPEARS TO  
BE THIN, WH, SKIM COAT ON  
OLDER PLASTER. PLASTER  
EXTENDS UP TO (NOT BEHIND)  
POST BOXING.
